1 **Service Life Evaluation of Corrugated Steel Pipe**
 2 **Storm Water Detention Systems in the Metropolitan Washington, DC Area**
 3 3251 words, 2 figures, 5 tables

4
 5 J. Peter Ault, PE
 6 Senior Engineer
 7 Corrpro Companies, Inc.
 8 Tennessee Ave. & Beach Thorofare
 9 Ocean City, NJ 08226
 10 609-399-2417
 11 PAult@Corrpro.com
 12
 13

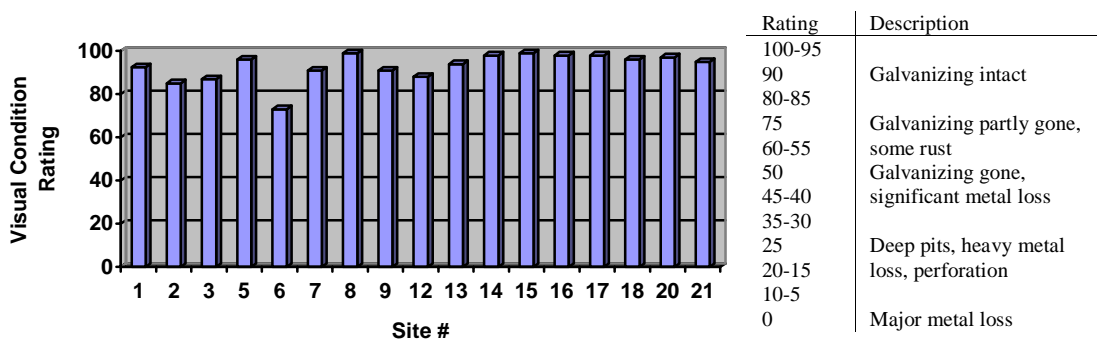
36 **FIGURE 1 Condition Rating of Corrugated Steel Pipe Detention Systems**

29 Corrugated steel pipe (CSP) storm water detention systems (plain galvanized, aluminized, or bituminous coated)
 30 have been in use in the metropolitan Washington, DC area since the early 1970s. A qualitative condition survey to
 31 assess the overall performance of 17 of these systems was conducted by Parsons Brinkerhoff on behalf of the
 32 National Corrugated Steel Pipe Association (NCSPA) in early 1998. The overall conclusion of the survey² was that
 33 the systems were performing extremely well. Figure 1 shows the average condition rating (crown, sides, invert)
 34 based on a visual rating scale.³ Most systems still had the zinc layer intact after about 25 years of service. There
 35 were no signs of visible deflection and most joints appeared to be soil tight.

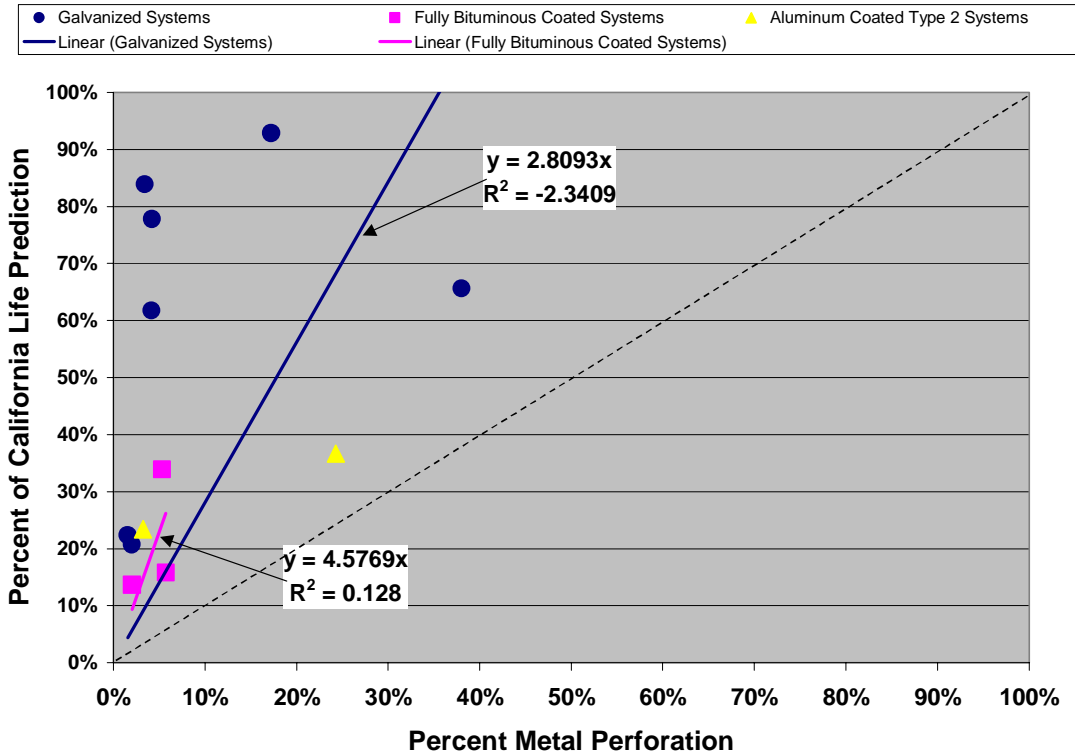
Figure 2. Percent Metal Perforation vs. California Prediction

To better understand the relationship between the California Method predictions and existing conditions, Potter correlated percent penetration with percent of California predicted service life expended.⁶ While there has been extensive debate over the validity of the technique, it is used here to compare service life predictions. Table 5 presents the minimum overall metallic thickness (steel plus metallic coating) measured on all coupons from each system. That value is compared with the "original" thickness. The original thickness was determined in most cases by measuring overall thickness on the crown of the pipe where the metallic coating was metallographically determined to be intact at nominally the original thickness. System 6 was the only system where an original thickness was difficult to determine, but a sufficiently conservative estimate was made based on measurements of the coupons. Figure 2 shows the data plotted in a manner similar to that used by Potter. Best-fit lines were regressed through all of the data for galvanized and asphalt coated pipes. No plot was made for aluminum coated pipes due to a lack of sufficient number of data points.

Using all data points, the analysis suggests that the galvanized systems are performing 2.8 times as well as the California Method would predict while the fully bituminous coated systems are performing 4.6 times as well as the California Method would predict for galvanized material. It should be noted that this multiplier increases to 7.3 times for galvanized systems if Site #6 is ignored. The data collected from these detention systems support the conclusion that the galvanized detention systems will last longer than the California Method would predict for culverts.
